PCN – Process Change Notification

Change:	AGGP.25F.07.0060A
Date:	2017/3/17
Author	Haley Tsai

Model#	Part Number	Changes			
AGGP.25F GPS/GLONASS 2 Stage Active Patch 25mm, 60mm Ø1.13	AGGP.25F.07.0060A	To change soldering process from manual to auto soldering machine

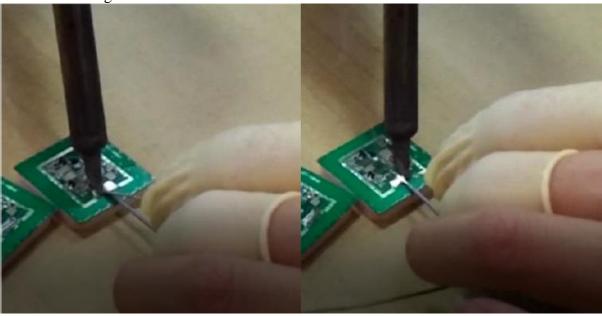
Old Soldering Process

Customer reply to have cable breaking issue, therefore we change the following production procedure to avoid cable breaking.

Manual soldering

- 1. Taoglas has changed soldering process to auto soldering machine, which prevent insulation of \emptyset 1.13 cable melted.
- 2. Change the soldering order from path antenna pin, core wire, and braid shield to braid shield, core wire, and path antenna pin

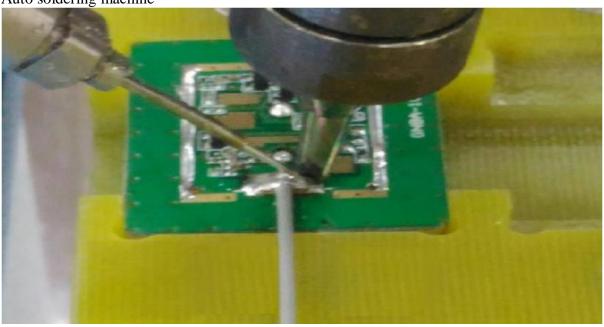
New Soldering Process

Auto soldering machine

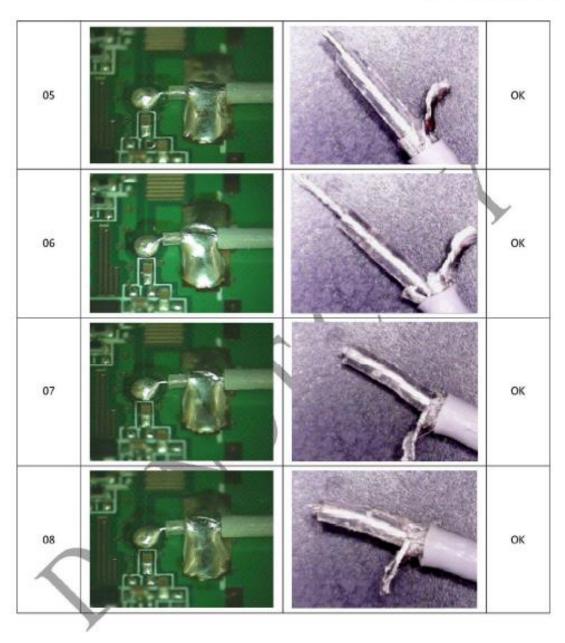
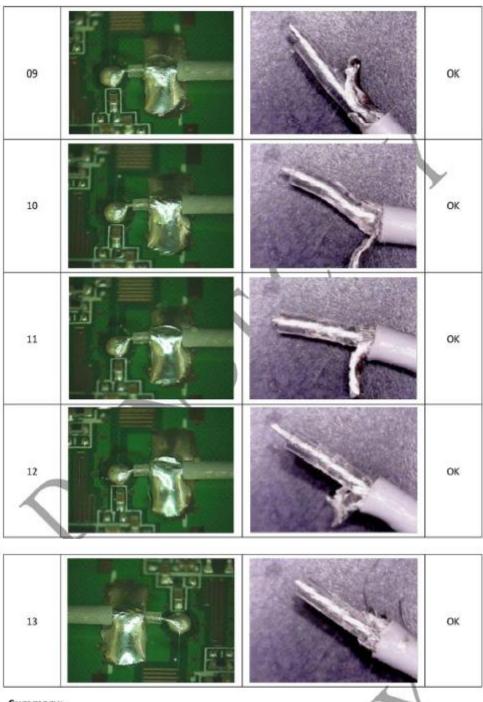
Auto Soldering Machine Destructive Test Report

Check the insulation under the braid shield after destructive, 13 PCS all pass have no any damage.
