PCN – Process Change Notification

Change:	Remove protection cap from IPEX MHF1 & MHF2 connectors
Date:	2018/05/22
Author	Haley

Taoglas Taiwan Reliability Test Lab

: TTR-18-0606-01

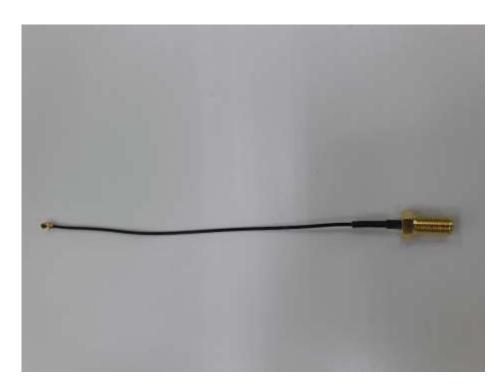
Product picture:

Product Category: Cable

Product Series Name: CAB Series

Product Model Part No.: CAB.6047

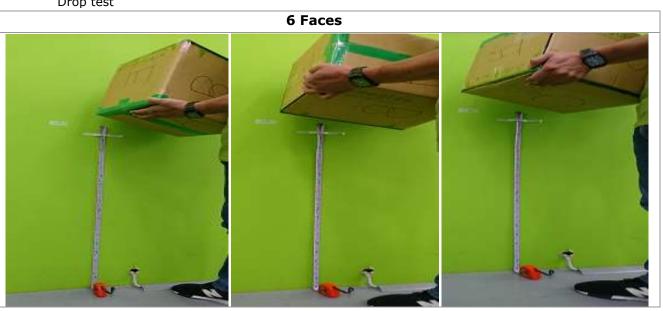
Drop test

Sample condition: Packed

100 cm Drop Height:

Test times Total:10 times

Test surface: Ground

Test Standard: IEC 60068-2-32

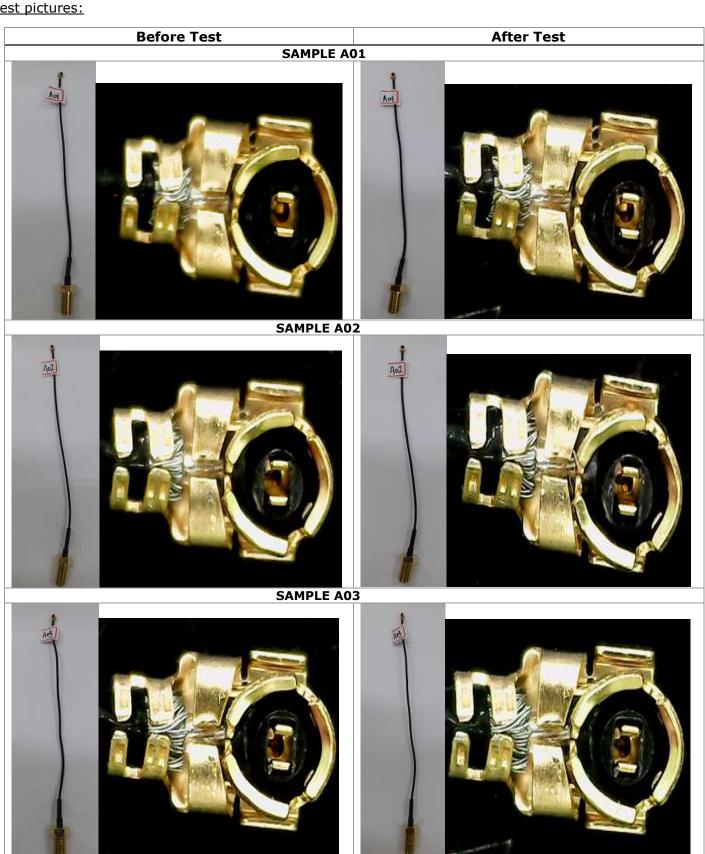
4.2.Test pictures:

Item No./Part No.	Visual Inspection Result	PASS/FAIL
Sample A01	No visible damage or cable scratch	PASS
Sample A02	No visible damage or cable scratch	PASS
Sample A03	No visible damage or cable scratch	PASS
Sample A04	No visible damage or cable scratch	PASS
Sample A05	No visible damage or cable scratch	PASS
Sample A06	No visible damage or cable scratch	PASS
Sample B01	No visible damage or cable scratch	PASS
Sample B02	No visible damage or cable scratch	PASS
Sample B03	No visible damage or cable scratch	PASS
Sample B04	No visible damage or cable scratch	PASS
Sample B05	No visible damage or cable scratch	PASS
Sample B06	No visible damage or cable scratch	PASS
Sample C01	No visible damage or cable scratch	PASS
Sample C02	No visible damage or cable scratch	PASS
Sample C03	No visible damage or cable scratch	PASS
Sample C04	No visible damage or cable scratch	PASS
Sample C05	No visible damage or cable scratch	PASS

5.1 The Drop test result for CAB.6047 shows PASS

CAB.6047 Ipex connector without cap Passed drop test

Visual inspection: PASS
