PCN – Process Change Notification

Change:	AGGP.25F.07.0060A
Date:	2017/3/17
Author	Haley Tsai

Model#	Part Number	Changes			
AGGP.25F GPS/GLONASS 2 Stage Active Patch 25mm, 60mm Ø1.13	AGGP.25F.07.0060A	To change soldering process from manual to auto soldering machine

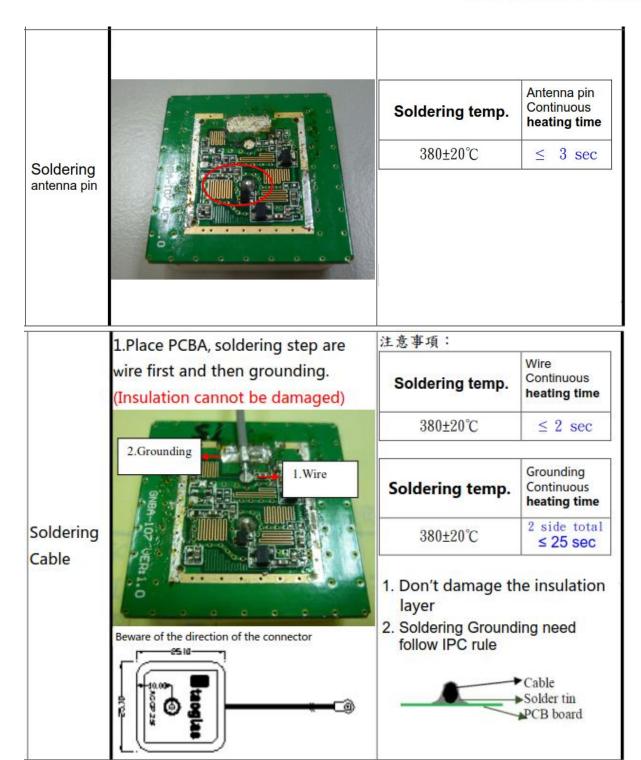
Old Soldering Process

Customer reply to have cable breaking issue, therefore we change the following production procedure to avoid cable breaking.

Manual soldering

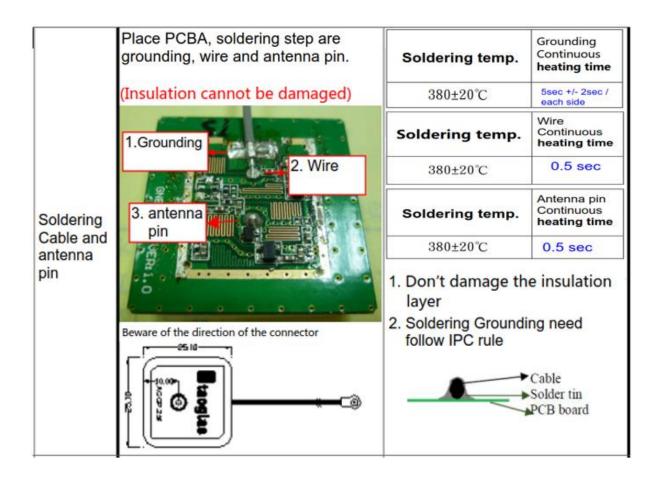
New Soldering Process

Auto soldering machine

- 1. Taoglas has changed soldering process to auto soldering machine, which prevent insulation of \emptyset 1.13 cable melted.
- 2. Change the soldering order from path antenna pin, core wire, and braid shield to braid shield, core wire, and path antenna pin
